CITY CENTRE WEST TO EAST CYCLE LINK

Road Safety Audit Stage 1 Designers Response

City of Edinburgh Council

636809_0_RP_Z_00_0030

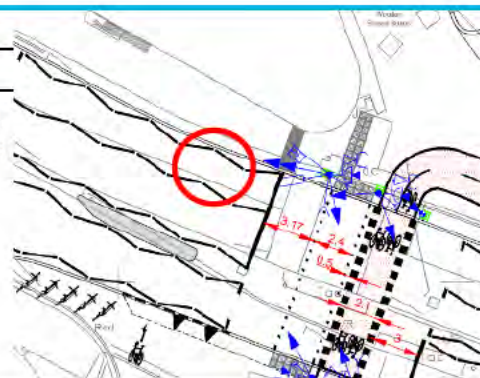
Summary: Narrow lane width could lead to side-swipe, shunt, loss of control, and / or vehicular-pedestrian collisions

The nearside eastbound lane on approach to the new crossing of Roseburn Terrace is very narrow at approximately 2 m wide. A motorist in the offside lane following the central zig-zag road markings may veer into the path of an adjacent nearside vehicle, with the potential for side-swipe and / or shunt type collisions to occur. This may also cause a motorist in the nearside lane to hit and / or overrun the kerb. Striking the kerbs could lead to vehicles losing control. Regular overrunning of kerbs could also lead to break up of the footways and kerbs. This could lead to loose material in the carriageway with the potential for loss of control collisions. Any vehicles overrunning the kerbs could also collide with pedestrians behind the kerb.

It is recommended that the lane widths are adjusted to ensure that vehicles can travel side by side within their lanes.

Recommendation accepted.

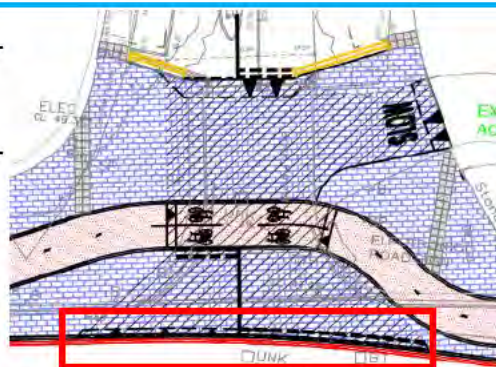
| Summary: | Steep ramp at raised table could lead to loss of control collisions |

The proposed ramps at raised tables at several locations are very short and will therefore be steep. Motorists turning into the side roads may not appreciate the presence of the ramps until they turn in and could lose control whilst turning on a steep ramp. Powered two-wheeler vehicles are particularly at risk of losing control during turning and braking on a steep ramp. This occurs at the following locations:

It is recommended that the ramp gradients throughout the scheme are suitable for all motorised vehicles to negotiate safely.

Recommendation accepted.

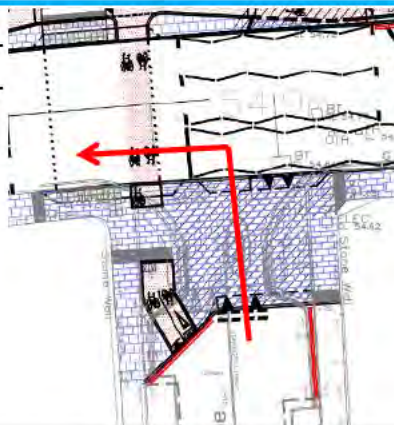
Problem 4.1.5**Location(s)** Stanhope Street**Drawing(s)** TDD-636809-1.5-DR-CH-00-0005**Summary:** Proximity of crossing to junction could lead to vehicular-cyclist and / or head-on collisions

It is recommended that swept paths are undertaken for all movements at the junction, and the layout is amended to remove the risk of collisions. For example, Stanhope Street could be made one-way, or be closed, or the crossing could be relocated.

Recommendation accepted.

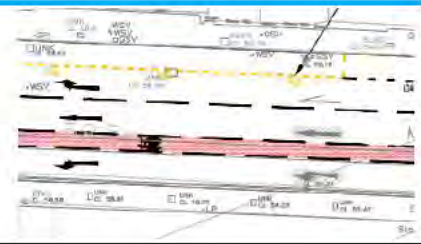
Problem 4.1.7**Location(s)** Morrison Street**Drawing(s)** TDD-636809-1.7-DR-CH-00-0007**Summary:** Buses travelling across the cycle lane could lead to bus-cyclist collisions

It was observed during the audit site visit that buses in the nearside lane were driving within the existing cycle lane. This has the potential for collisions between buses and cyclists.

It is recommended that the swept paths of vehicles including buses are undertaken along this road, and lane widths adjusted as necessary.

Recommendation accepted.

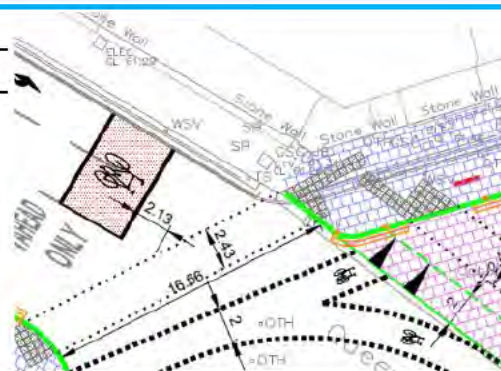
| Summary: | Kerb alignment could lead to vehicular-pedestrian and / or loss of control collisions |

The proposed amendments to the nearside kerb between Drumsheugh Place and Randolph Place do not produce a smooth alignment. As such it is likely that the new corner kerb will be overrun by vehicles turning left into Randolph Place. This could lead to collisions between vehicles and pedestrians waiting to cross. Regular overrunning of kerbs could also lead to break up of the footways and kerbs. This could lead to loose material in the carriageway with the potential for loss of control collisions.

It is recommended that the kerb ties in smoothly, and its alignment accommodates the swept path of vehicles expected at the junction.

Recommendation accepted.

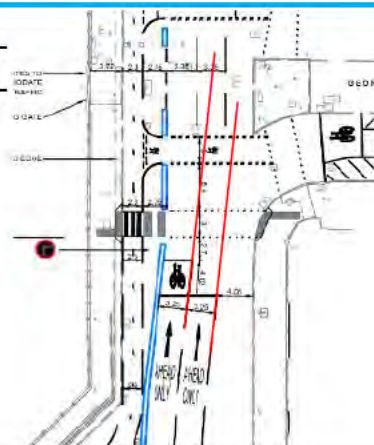
| Summary: | Lane alignment could lead to head-on, side-swipe and / or loss of control collisions |

It is recommended that the road markings and kerb lines are adjusted as necessary to improve the lane alignment through the junction.

Recommendation accepted.

A straighter alignment for northbound lanes through the George Street junction is not possible within the constraints of the site and the need to provide cyclist and pedestrian facilities on the west side of the junction. However, the alignment will be further highlighted through additional Diag 1004 hazard warning lines between the pedestrian and cycle crossings on the southern arm of the junction.

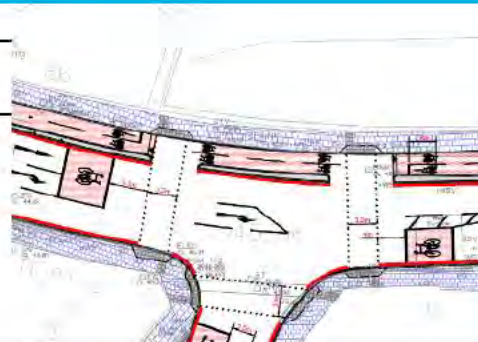
Summary: Narrow islands could lead to loss of control collisions

It is recommended that the islands are made wide enough for their presence to be highlighted without the risk of vehicles or cyclists striking kerbs or any street furniture.

Recommendation rejected (alternative solution proposed).

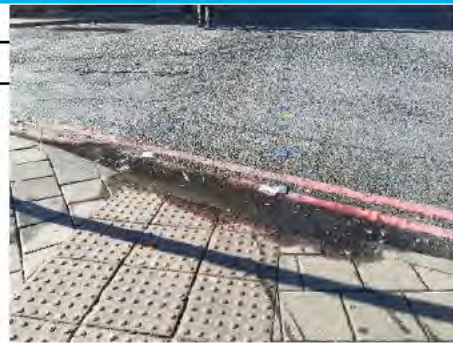
Problem: 4.2.2**Location(s):** Roseburn Terrace / Russell Street junction**Drawing(s):** TDD-636809-1.3-DR-CH-00-0003**Summary:** Standing water could lead to loss of control collisions and / or slips and falls for pedestrians / cyclists

Standing water was observed on the carriageway at the western side of the Roseburn Street pedestrian crossing. Standing water can freeze during wintry conditions, with the potential to cause loss of control collisions for vehicles and slips and falls for pedestrians / cyclists.

It is recommended that existing drainage is reviewed, and gullies unblocked, and / or additional gullies added as necessary to prevent standing water from occurring.

Recommendation accepted.

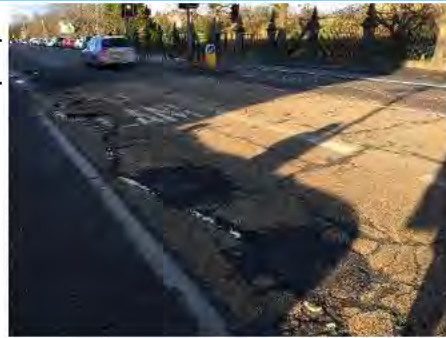
| Summary: | Poor pavement condition at crossing could lead to personal injury for pedestrians |

The existing pavement is in a poor condition at the location of the proposed uncontrolled crossing to the west of Devon Place. Pedestrians using the crossing may trip and fall leading to personal injury.

It is recommended that a smooth pavement surface is provided at the crossing point.

Recommendation accepted.

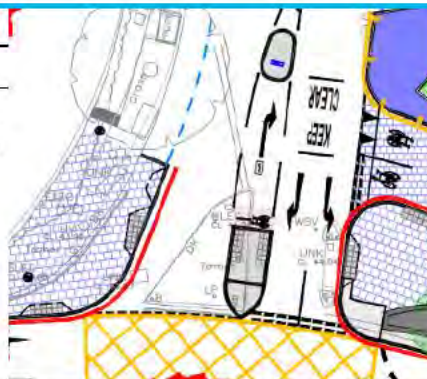
Summary: Reduced road width could lead to loss of control collisions and / or vehicular-pedestrian / cyclist collisions

Kerb lines are being realigned in order to widen the footway provision. There is the potential for large vehicles to hit and / or overrun the kerbs at the entry to, and exit from, Murrayfield Avenue, noting the narrow lanes at exit. Striking the kerbs could lead to vehicles losing control. Regular overrunning of kerbs could also lead to break up of the footways and kerbs. This can lead to loose material in the carriageway with the potential for loss of control collisions. Any vehicles overrunning the kerbs could also collide with pedestrians and / or cyclists behind the kerb.

It is recommended that swept path analyses are undertaken to ensure that large vehicles can undertake all movements without overrunning the adjacent kerbs.

Recommendation accepted.

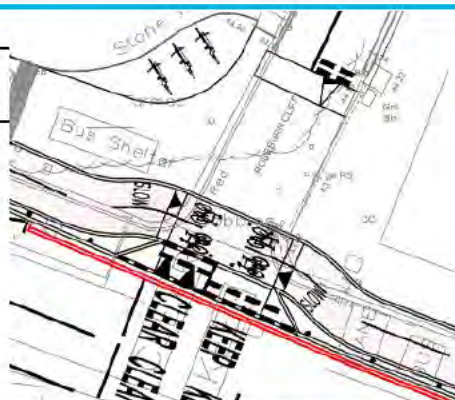
Problem: 4.3.2**Location(s):** Various (see below)**Drawing(s):** TDD-636809-1-DR-CH-SK-0036
TDD-636809-1.4-DR-CH-00-0004**Summary:** Set back of Give Way road markings and restricted visibility could lead to vehicular-cyclist collisions.

It is recommended that the Give Way markings are moved closer to Roseburn Terrace / West Coates to maximise visibility between cyclists and approaching vehicles.

Recommendation rejected.

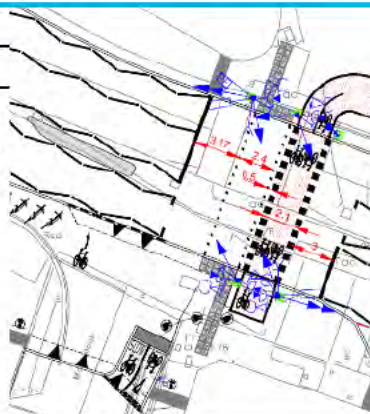
Summary: Turning movements at junction could lead to vehicular-pedestrian and / or vehicular-cyclist collisions

Recommendation accepted in part.

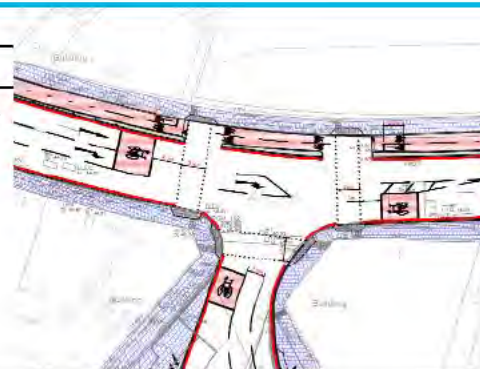
Problem: 4.3.4**Location(s):** Roseburn Terrace / Russell Road junction**Drawing(s):** TDD-636809-1.3-DR-CH-00-0003**Summary:** Concurrent green signals could lead to vehicular-cyclist collisions

It is recommended that the cycleway does not have a green signal at the same time as Russell Road.

Recommendation rejected.

The auditor's comments are noted and this alternative method of operation has been considered through the design process. There are two reasons the chosen staging has been selected:

1) Anecdotal evidence emerging from cities that have installed segregated cycle facilities is that where cyclists are unnecessarily delayed, for example when non-conflicting side roads are running, there is a tendency for cyclists to ignore red signals. At this location that could result in cyclists from Russell Road joining the cycle track as a cyclist passes through a red signal. This has been weighed against the risk of a cyclist needing to slow and find a gap in cyclists utilising the track. However the operation will be monitored and the configuration can be adjusted if there are observed issues.

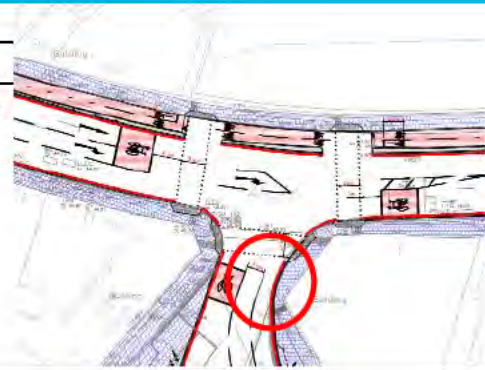
Problem: 4.3.5**Location(s):** Roseburn Terrace / Russell Road junction**Drawing(s):** TDD-636809-1.3-DR-CH-00-0003**Summary:** Narrow lanes could lead to side-swipe, shunt and / or head-on collisions

It is recommended that the entry to Russell Road is marked as a single lane, widening to two lanes where there is sufficient width for two vehicles to travel side by side.

Recommendation accepted.

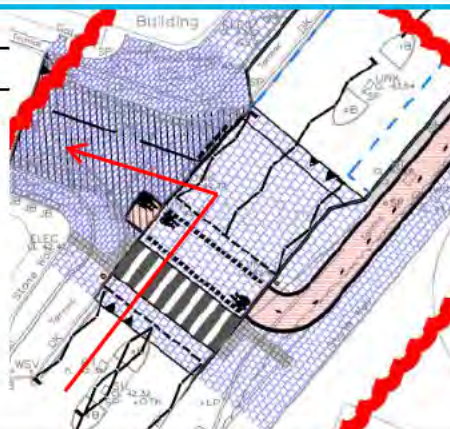
Problem: 4.3.6**Location(s):** Roseburn Place / Roseburn Street junction**Drawing(s):** TDD-636809-1.3-DR-CH-00-0003**Summary:** Proximity of crossing to side road could lead to vehicular-pedestrian / cyclist collisions, and / or head-on collisions

It is recommended that the crossing is relocated such that all turning movements can be performed without risk of overrunning pedestrian / cycle waiting areas or travelling in an opposing traffic lane towards oncoming traffic.

Recommendation rejected (alternative solution proposed).

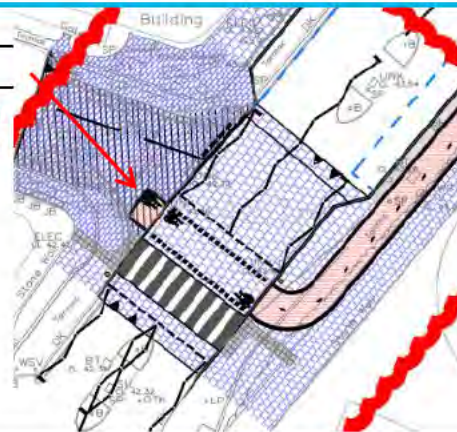
Problem: 4.3.7**Location(s):** Roseburn Place / Roseburn Street junction**Drawing(s):** TDD-636809-1.3-DR-CH-00-0003**Summary:** Location of cycleway crossing could lead to head-on and / or side-impact collisions between vehicles and cyclists

It is recommended that appropriate measures are provided to allow eastbound cyclists to safely access the cycleway crossing.

Recommendation accepted.

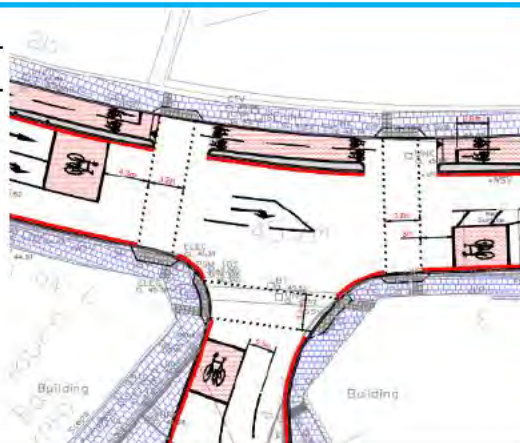
Lack of facilities for cyclists to cross the junction could lead to shunt, side-impact and / or side-swipe collisions with vehicles.

It is recommended that provision is made for cyclists to safely cross West Coates in order to continue to Russell Road / Roseburn Street.

Recommendation accepted: Crossing facilities are provided along Roseburn Terrace and West Coates however these are provided based on desire lines and constraints. There is a wider routing strategy for access to the CCWEL corridor that will be signed accordingly, which offers a more appropriate off-carriageway facility than the exiting on-carriageway via Russell Road.

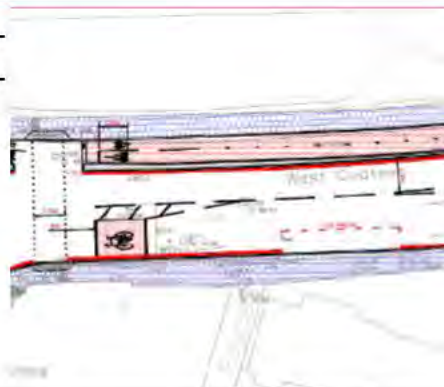
| <i>Summary:</i> | Proximity of loading bay to nearside signal could lead to shunt, side-impact and / or vehicular-pedestrian collisions |

It is recommended that measures are incorporated to ensure that the traffic signals can be seen should the loading bay be occupied, such as increased height signals, and offside primary signals. If this is not possible then it is recommended that the loading bay is relocated outside of the visibility splay for the signals.

Recommendation accepted.

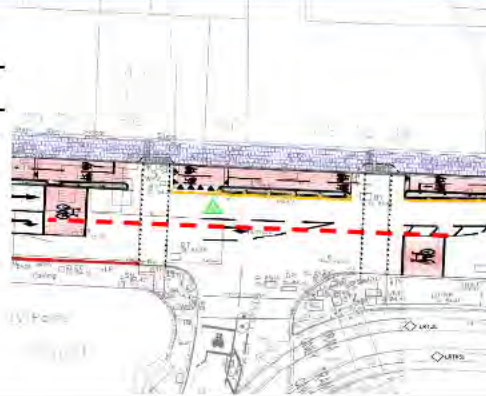
| <i>Summary:</i> | Lane alignment through junction could lead to head-on, shunt and / or loss of control collisions |

It is recommended that the westbound approach lane is aligned with the westbound departure lane from the junction.

Recommendation accepted.

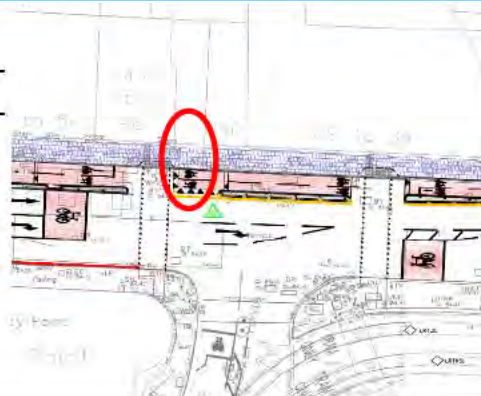
| Summary: | Swept paths of vehicles could lead to head-on and / or loss of control collisions |

Recommendation accepted.

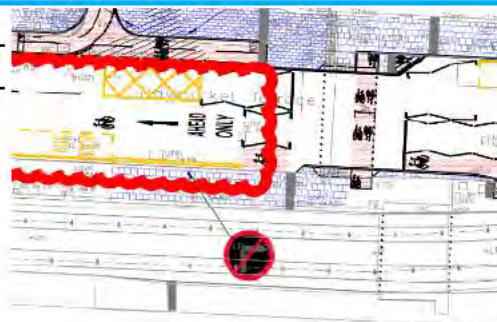
Summary: Short merge length could lead to shunt and / or side-swipe collisions between vehicles and cyclists

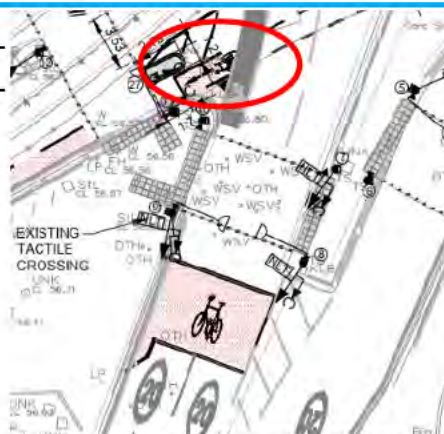
| Summary: | Signal staging and storage length could lead to side-impact, side-swipe and / or shunt collisions |

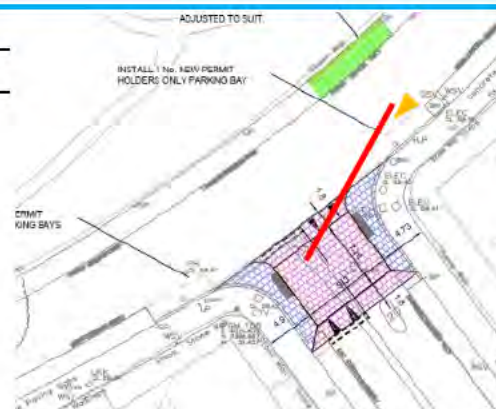
Summary: Restricted visibility on a bend could lead to vehicular-cyclist collisions

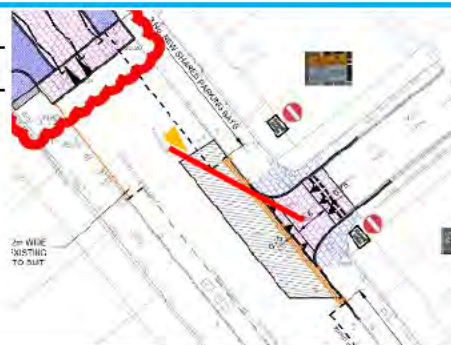
| Summary: | Restricted visibility could lead to vehicular-cyclist collisions |

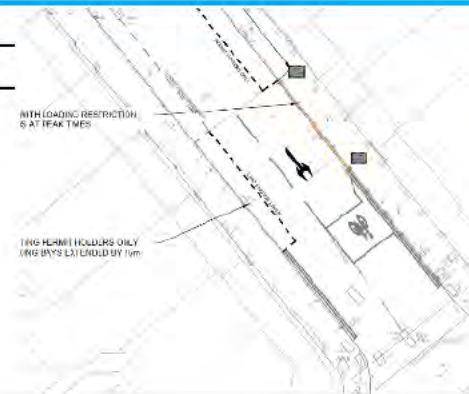
| Summary: | Wide single lane could lead to side-swipe collisions |

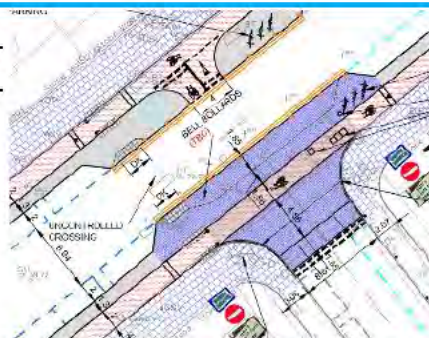
| Summary: | Junction geometry could lead to vehicular-pedestrian and / or loss of control collisions |

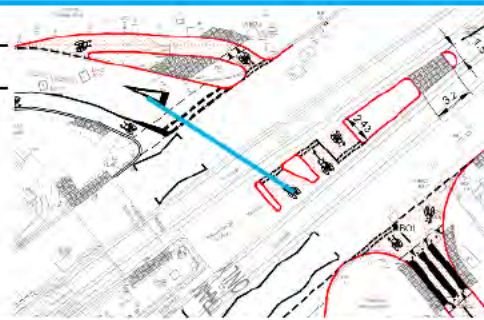
| Summary: | Position of cycle refuge could lead to head-on collisions |

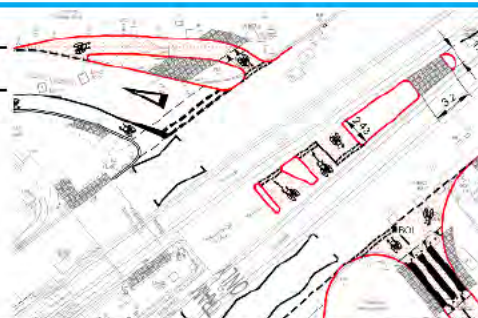
| Summary: | Small cycle refuge islands could lead to tram-cyclist collisions |

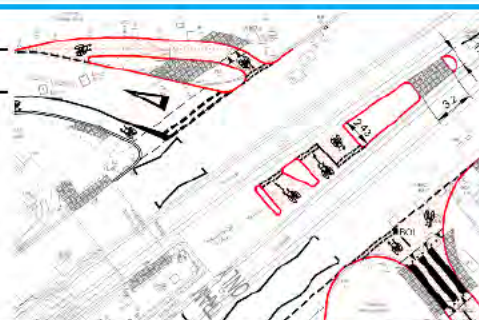
| Summary: | Proximity of zebra crossing to junction could lead to vehicular-cyclist collisions |

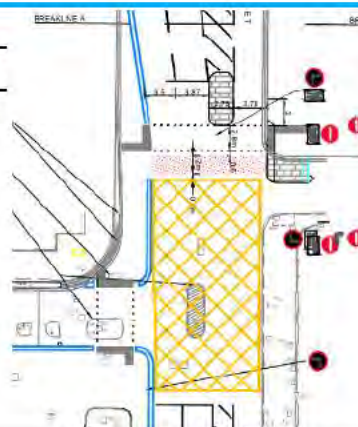
Summary: Lack of stop line road markings could lead to side-impact and / or vehicular-pedestrian collisions

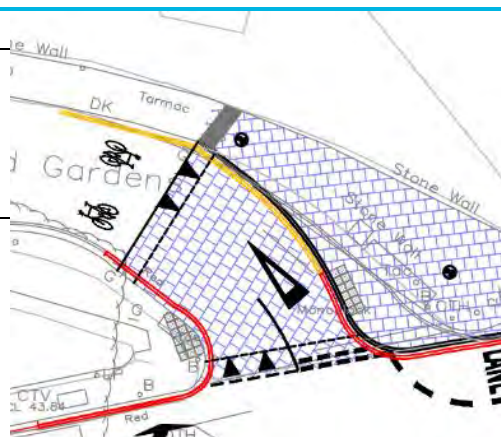
Summary: Raised tables flush with adjacent footways could result in vehicular-pedestrian collisions for the visually impaired.

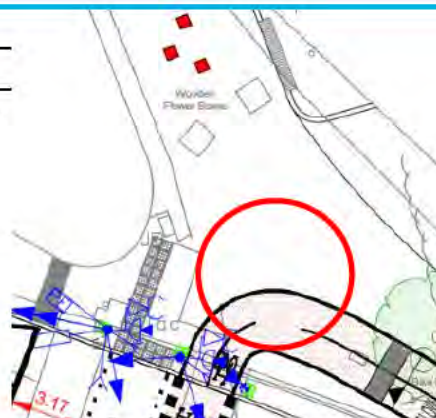
Problem: 4.4.2**Location(s):** Roseburn Terrace**Drawing(s):** TDD-636809-1-DR-CH-SK-0036**Summary:** Lack of connecting facilities could lead to cyclist-pedestrian and / or cyclist-cyclist collisions

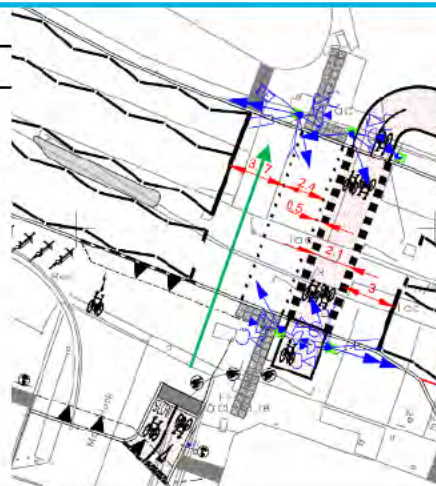
Summary: Alignment of cycleway in conjunction with dropped kerbs could lead to inappropriate use of the crossing and cyclist-pedestrian and / or cyclist-cyclist collisions

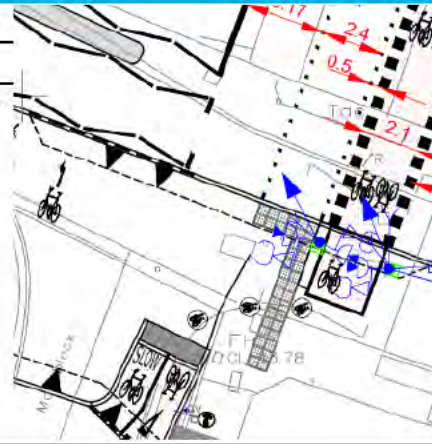
Summary: Steep gradient could lead to vehicular-wheelchair collisions

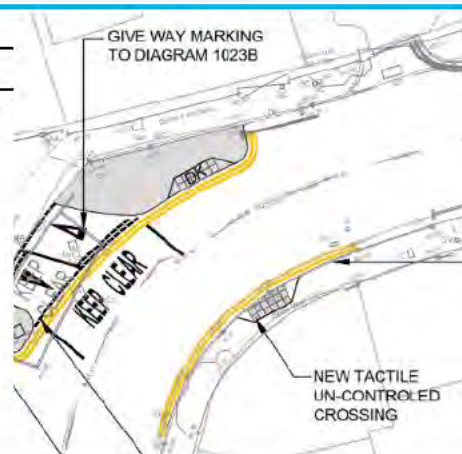
Problem: 4.4.5**Location(s):** Roseburn Crescent**Drawing(s):** TDD-636809-1.2-DR-CH-00-0002**Summary:** Insufficient visibility to pedestrians at a crossing could lead to vehicular-pedestrian collisions

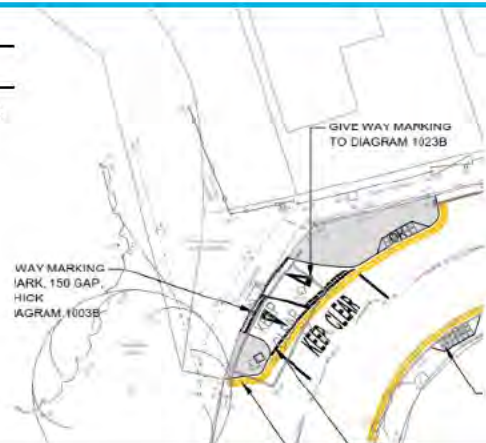
Problem: 4.4.6**Location(s):** Roseburn Crescent**Drawing(s):** TDD-636809-1.2-DR-CH-00-0002**Summary:** Lack of tactile guidance could lead to collisions between visually impaired pedestrians and cyclists

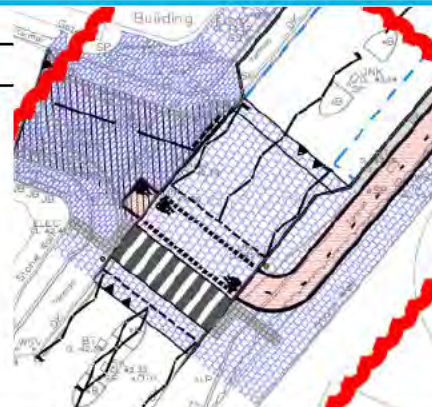
Problem: 4.4.7**Location(s):** Roseburn Place / Roseburn Street junction**Drawing(s):** TDD-636809-1.3-DR-CH-00-0003**Summary:** Lack of tactile guidance could lead to collisions between visually impaired pedestrians and cyclists

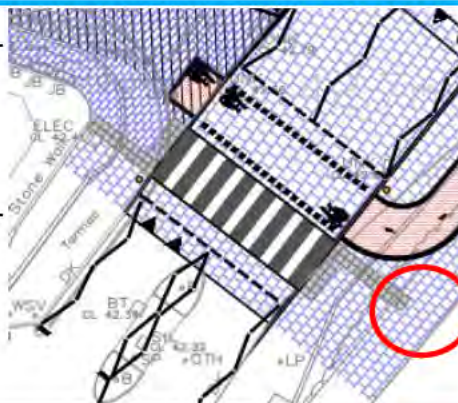
| Summary: | Insufficient tactile paving could lead to vehicular-pedestrian collisions |

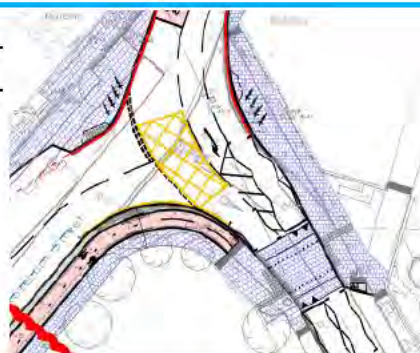
Long crossing distance combined with restricted visibility could lead to vehicular-pedestrian collisions

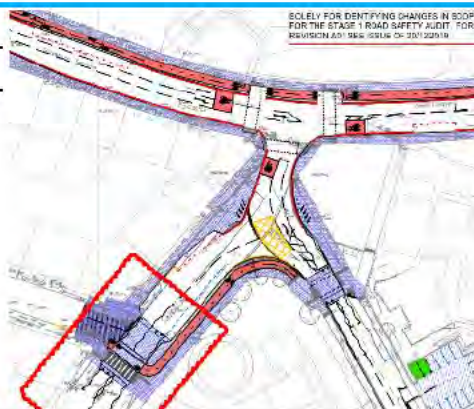
| Summary: | Lack of connectivity between cycle features could lead to vehicular-cyclist collisions |

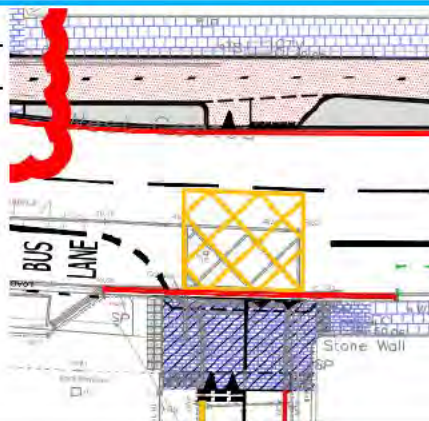
Summary: Width, and location, of cycle crossing could lead to vehicular-cyclist collisions

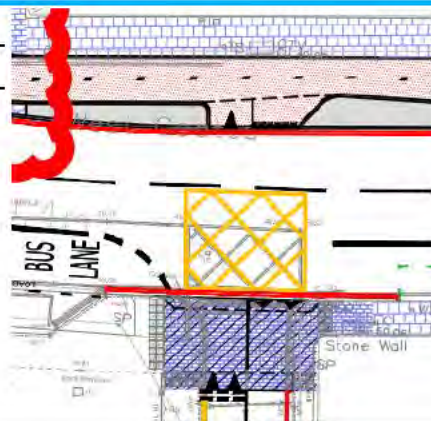
| Summary: | Insufficient storage length for bicycles could lead to loss of control, cyclist-cyclist, vehicular-cyclist and / or head-on collisions |

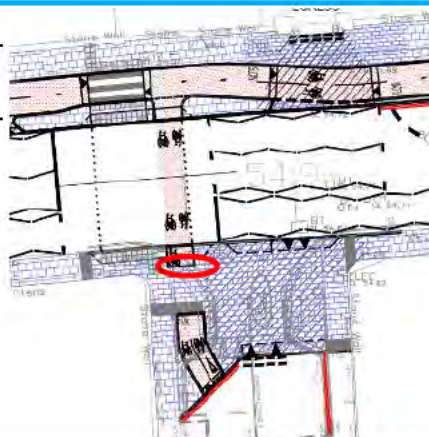
| Summary: | Lack of tactile guidance could lead to collisions between visually impaired pedestrians and cyclists |

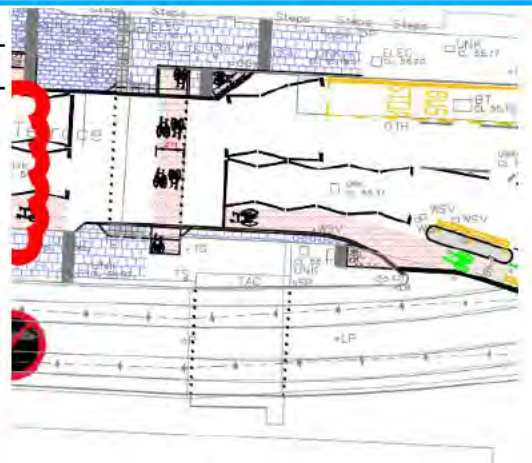
Summary: Unclear continuation of cycle route could lead to cyclist-pedestrian collisions

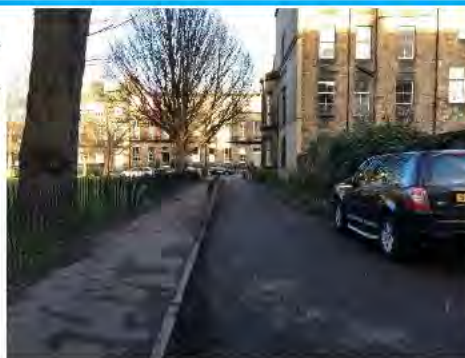
| Summary: | Narrow, unlit road with bollards in close proximity, could lead to head-on and / or loss of control collisions |

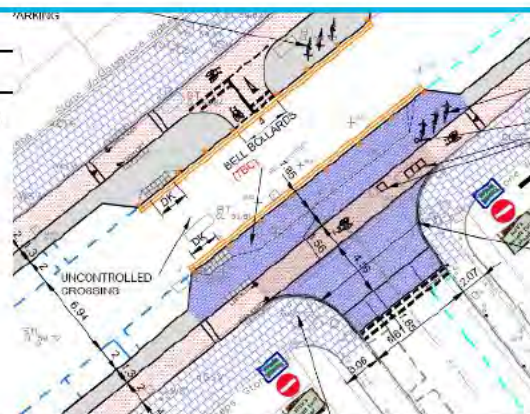
Problem: 4.4.21**Location(s):** Stafford Street**Drawing(s):** TDD-636809-2.7-DR-CH-00-0007**Summary:** Lack of tactile guidance could lead to collisions between visually impaired pedestrians and cyclists

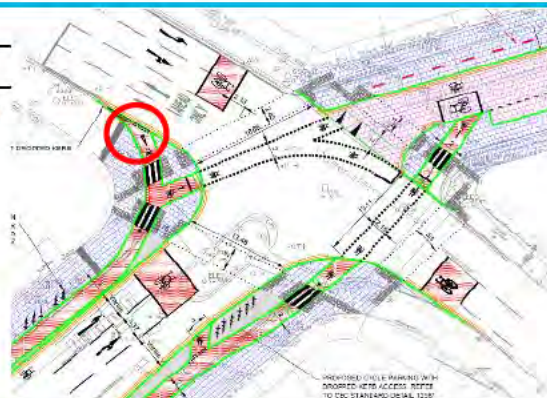
Problem: 4.4.22**Location(s):** Melville Street / Drumshaugh Place**Drawing(s):** TDD-636809-2-DR-CH-SK-0030**Summary:** Low entry angle of cycleway could lead to vehicular-cyclist collisions

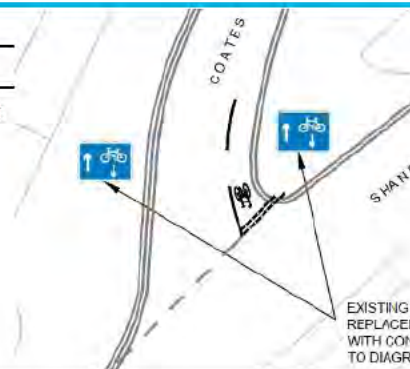
Problem: 4.4.23**Location(s):** Coates Crescent / Shandwick Place**Drawing(s):** TDD-636809-2.9-DR-CH-00-0009**Summary:** Lack of cycle provision could lead to vehicular-cyclist collisions

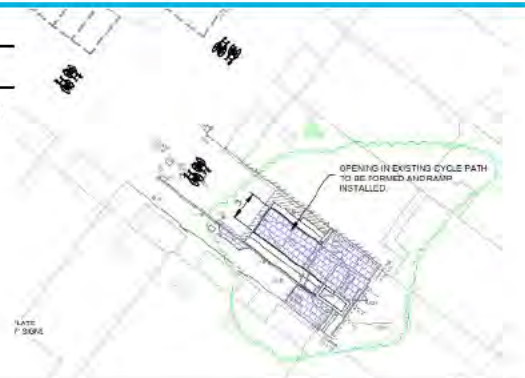
Problem: 4.4.24**Location(s):** Rutland Square**Drawing(s):** TDD-636809-2.11-DR-CH-00-0011**Summary:** Limited visibility, and speed of cyclists on ramp could lead to vehicular-cyclist collisions

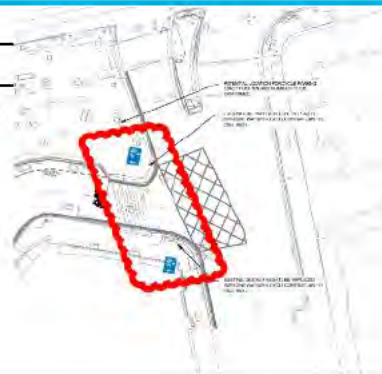
Problem: 4.4.25**Location(s):** Rutland Street / Lothian Road**Drawing(s):** TDD-636809-2.12-DR-CH-00-0012**Summary:** Lack of continuation of cycle facilities could lead to vehicular-cyclist collisions

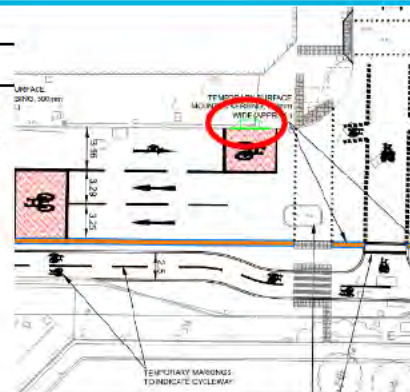
Summary: Dropped kerb adjacent to crossing could lead to vehicular-pedestrian collisions and / or pedestrian trips, leading to personal injury.

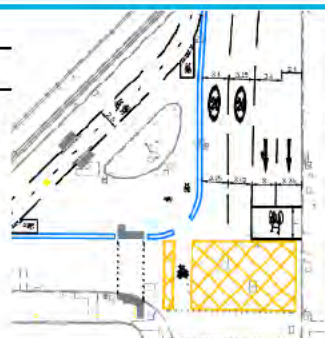
Problem: 4.4.27**Location(s):** Charlotte Square**Drawing(s):** TDD-636809-4-DR-CH-SK-0007**Summary:** Lack of information for visually impaired pedestrians could lead to trips and falls, and / or cyclist-pedestrian collisions

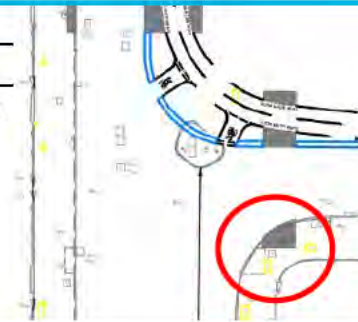
Problem: 4.4.28**Location(s):** Charlotte Square / Hope Street**Drawing(s):** TDD-636809-4-DR-CH-SK-0007**Summary:** Close proximity of crossings could lead to trips and falls for the visually impaired.

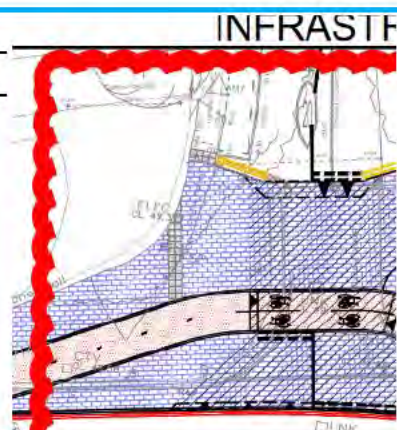
Lack of provision for cyclists at access to Roseburn Path could lead to cyclist-pedestrian collisions

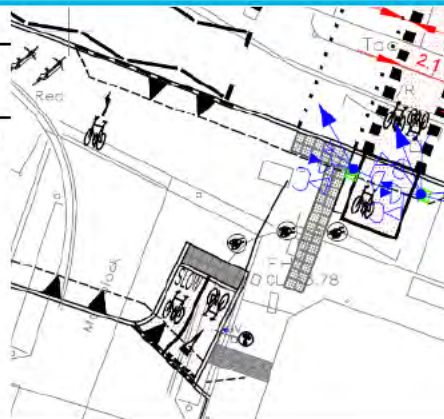
Problem: 4.5.2**Location(s):** Murrayfield Gardens to Roseburn Gardens**Drawing(s):** TDD-636809-1.1-DR-CH-00-0001
TDD-636809-1-DR-CH-SK-0036**Summary:** Polished roundels could lead to pedestrian / cyclist slips and falls, leading to injury.

Recommendation accepted: Shared use/cycle roundels to be installed similar to those installed elsewhere within Edinburgh providing an appropriate surface material to reduce the risk of slipping when wet.

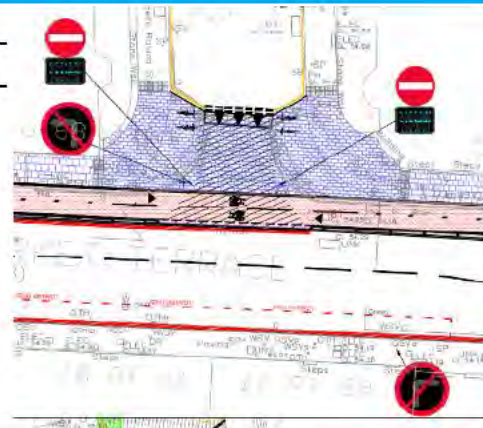
Summary: Inconsistent signage could lead to hesitation and shunt vehicular-cyclist collisions

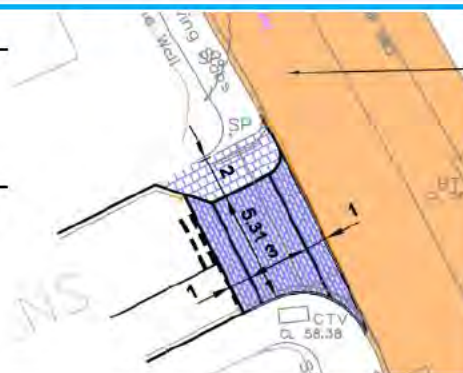
| Summary: | Lack of delineation of raised table could lead to loss of control collisions |

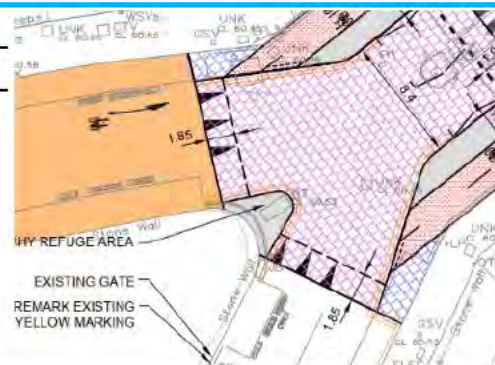
Problem 4.5.8**Location(s)** Grosvenor Crescent / Lansdowne Crescent**Drawing(s)** TDD-636809-2.3-DR-CH-00-0003**Summary:** Location of triangle markings on ramps could lead to head-on collisions

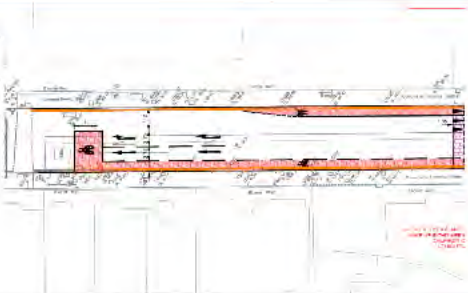
| Summary: | Lack of road markings could lead to head-on collisions |
| Recommendation: | <p>On the northbound approach to Chester Street there is a cycle lane, a straight-ahead lane, and a right turn lane proposed. However, the offside of the right turn lane is not delineated. As such, southbound motorists may drive across the start of the northbound right turn lane in particular as they move across to avoid the southbound cycle lane. This could lead to head-on collisions between southbound vehicles and northbound vehicles entering the right turn lane.</p> |

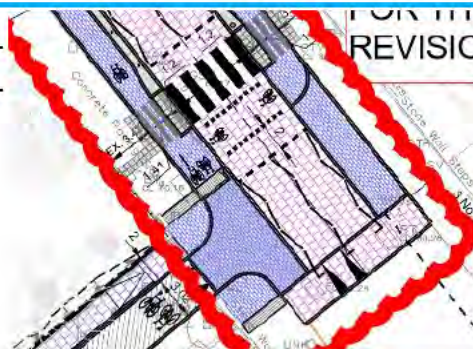
| Summary: | Lack of delineation could lead to vehicular-cyclist collisions |

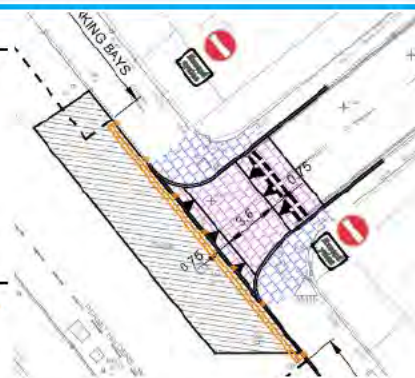
| Summary: | Lack of delineation of cycle lane could lead to vehicular-cyclist, and / or cyclist loss of control, collisions |

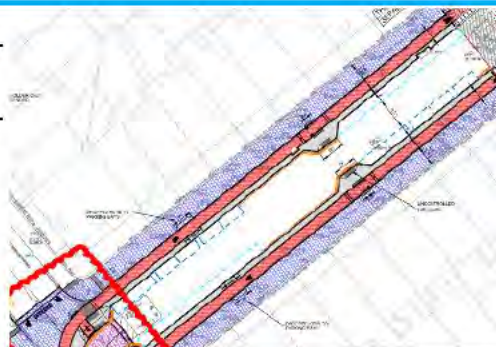
Summary: Lack of centreline road markings could lead to head-on collisions

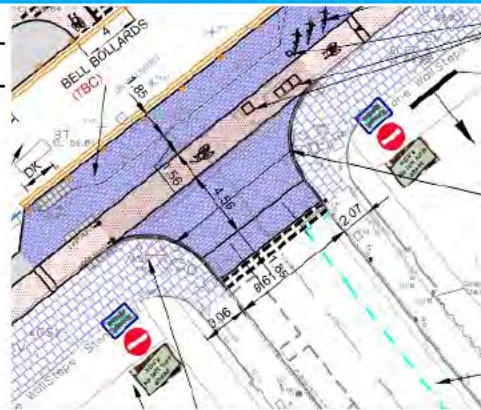
Summary: Ambiguous road signs could lead to vehicular-pedestrian collisions

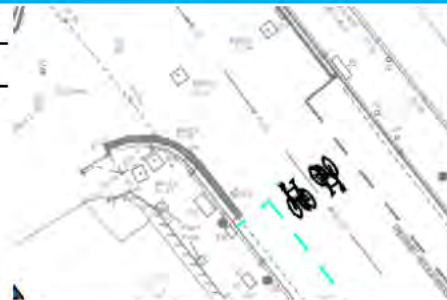
| Summary: | Contradicting road signs and road markings could lead to vehicular-cyclist collisions |

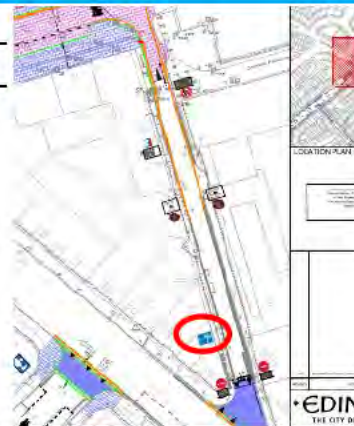
Summary: Sign orientation could lead to head-on collisions

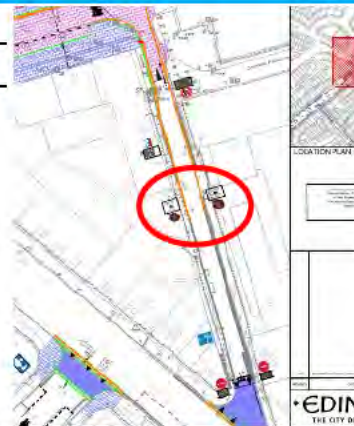
Summary: Position of signs could lead to vehicular-cyclist collisions

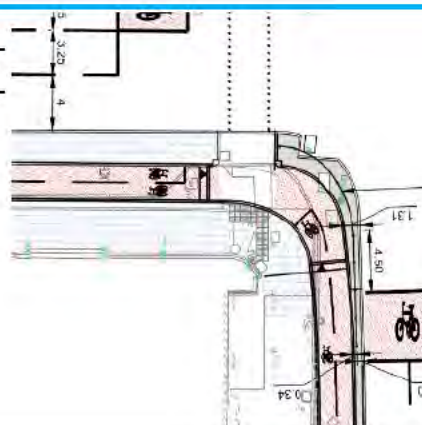
| <i>Summary:</i> | Straight alignment on approach to sharp bend and pedestrian crossing could lead to loss of control and / or cyclist-pedestrian collisions |
