CITY CENTRE WEST TO EAST CYCLE LINK

Road Safety Audit Stage 1 Designers Response

City of Edinburgh Council

636809_0_RP_Z_00_0030

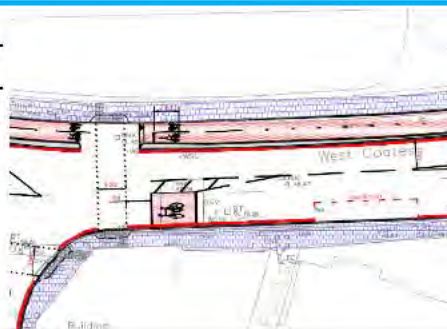
Drawing(s) TDD-636809-1.3-DR-CH-00-0003

Summary: Inconsistent lane width could lead to side-swipe collisions

A loading bay is proposed in the westbound carriageway to the east of the West Coates / Russell Road junction. The road is a single lane on the westbound approach, which widens to accommodate the loading bay, before narrowing to a single lane at the stop line. In the event that the loading bay is empty, and a large vehicle is following the kerb line, a following motorist may see the lane widening and attempt to overtake. This could result in a side-swipe collision as the overtaking motorist attempts to move across prior to the stop line.

It is recommended that road markings are provided on approach to the loading bay to guide motorists around it when empty.

Recommendation rejected.

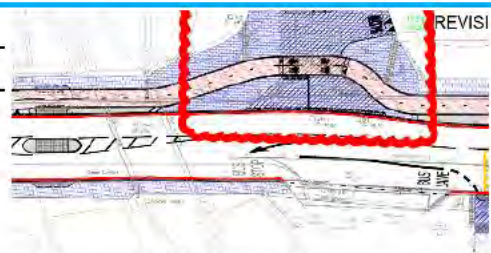
Short merge length could lead to side-swipe, shunt and / or loss of control collisions

The westbound approach to Balbirnie Place comprises a Bus Lane and a traffic lane. There is a gap in the Bus Lane across the junction with Balbirnie Place, before the Bus Lane re-commences. However, it only recommences for a short length. Motorists in the offside lane then have a very short distance to merge with the buses in the nearside lane in advance of a proposed central refuge. This short merge length could lead to side-swipe collisions between merging vehicles. It could also lead to shunt type collisions as vehicles brake suddenly if unsuccessful at merging. It could also lead to loss of control collisions should the offside vehicle strike the central refuge.

It is recommended that the short length of Bus Lane to the west of Balbirnie Place is removed and the road markings are amended accordingly to provide an appropriate merge taper length.

Recommendation rejected.

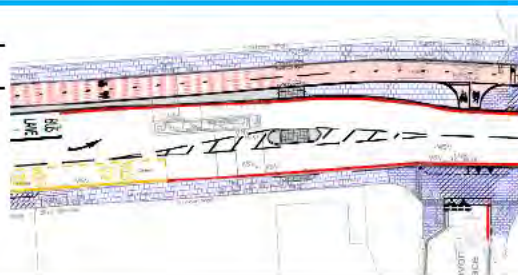
Drawing(s) TDD-636809-1.5-DR-CH-00-0005

Summary: Frequently changing alignment could lead to side-swipe, shunt and / or loss of control collisions

The eastbound approach to Devon Place comprises a Bus Lane and an offside lane, which then reduce to a single lane. Motorists in the offside lane have a very short distance to merge with the buses in the nearside lane in advance of a proposed central refuge. This short merge length could lead to side-swipe collisions between merging vehicles. It could also lead to shunt type collisions as vehicles brake suddenly if unsuccessful at merging. It could also lead to loss of control collisions should the offside vehicle strike the central refuge. Immediately after the refuge the road alignment curves to the right and then back to the left in quick succession. The combination of short merge taper and back to back short curves could exacerbate the potential for motorists to lose control at this location.

It is recommended that an appropriate merge taper length is provided, and the eastbound nearside kerb alignment is realigned to improve the travelled path for motorists.

Recommendation rejected.

The auditor's comments on the alignment are noted, however the constraints on this section of the corridor influencing the kerb line include:

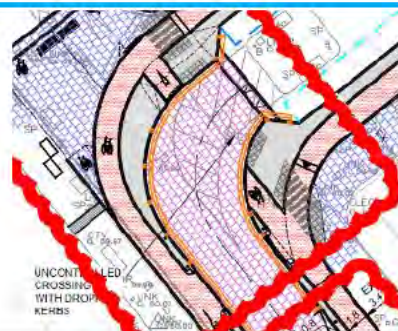
| <i>Drawing(s)</i> | TDD-636809-2.5-DR-CH-00-0005 |

| <i>Summary:</i> | Small radius curve and narrow pavement could lead to side-swipe, head-on and / or vehicular-pedestrian / cyclist collisions |

The road is to be made narrower around the ninety-degree bend between Manor Place and Melville Street. As such, it may be difficult for large vehicles (noting that a bus stop is present on Melville Street) to travel around the bend within their lanes, with the potential for side-swipe and / or head-on collisions to result. This may also result in vehicles overrunning the adjacent footway and cycleway with the potential for vehicular-pedestrian and / or vehicular-cyclist collisions.

It is recommended that swept paths are undertaken to ensure that vehicles using the route can undertake the movement within their lanes, and without overrunning the adjacent footway / cycleway, and the layout amended if necessary.

Recommendation accepted in part.

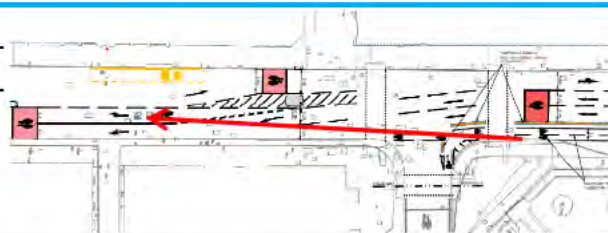
Problem 4.1.10**Location(s)** South St. David Street**Drawing(s)** TDD-636809-3-DR-CH-SK-0024**Summary:** Layout between junctions could lead to vehicular-cyclist collisions

Cyclists travelling south on South St. David Street wishing to turn right at Princes Street must merge with the nearside southbound traffic lane before weaving across the merging offside lane in order to enter the right turn lane. There is the potential for cyclists to be struck by vehicles as they attempt to weave through traffic that may be travelling at a faster speed. Even if cyclists are wishing to turn left at Princes Street, they will have to contend with both nearside and offside vehicles pulling across them, again with the potential for side-swipe and / or shunt type collisions.

It is recommended that the cyclists have their own signal stage in order to safely progress to the downstream junction.

Recommendation rejected.

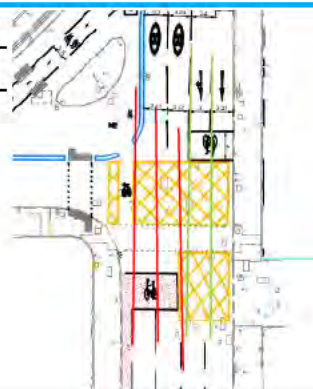
| Drawing(s) | TDD-636809-4-DR-CH-SK-0007 |

| Summary: | Lane alignment could lead to side-swipe and / or loss of control collisions |

| <p>The northbound lanes are not aligned across the junction (as per the red lines in the image above). Motorists in the offside lane may encroach into the nearside lane with the potential for side-swipe collisions. Also, vehicles in the nearside lane will be guided towards the kerb opposite. This could lead to motorists undertaking a sudden change in direction, with the potential for loss of control and / or side-swipe collisions to occur. Similarly, vehicles in the offside southbound lane may encroach into the nearside lane (as per the green lines in the image above) with the potential for side-swipe collisions.</p> |

| <p>It is recommended that the road markings and temporary kerb line are adjusted as necessary to improve the lane alignment through the junction.</p> |

| <p>Recommendation accepted.</p> |

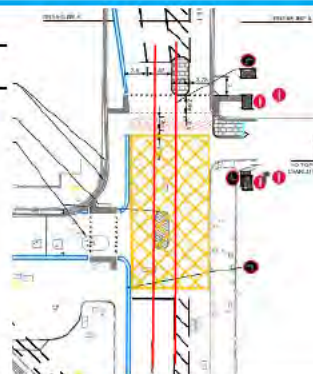
Drawing(s) TDD-636809-4-DR-CH-SK-0007

Summary: Lane alignment could lead to side-swipe and / or loss of control collisions

The northbound lanes are not aligned across the junction (as per the red lines in the image above). Motorists in the nearside lane may encroach into the offside lane with the potential for side-swipe collisions. Also, vehicles in the offside lane will be guided towards the kerb opposite. This could lead to motorists undertaking a sudden change in direction, with the potential for loss of control and / or side-swipe collisions to occur.

It is recommended that the road markings and kerb lines are adjusted as necessary to improve the lane alignment through the junction.

Recommendation accepted.

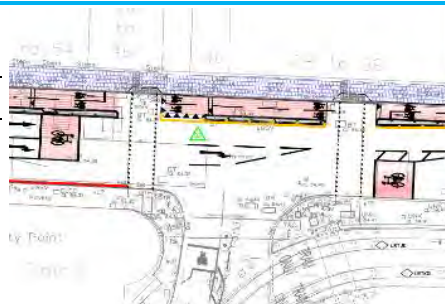
| Drawing(s) | TDD-636809-1.6-DR-CH-00-0006 |

| Summary: | Uncontrolled private access within junction could lead to vehicular-cyclist, head-on, and / or vehicular-pedestrian collisions |

A Thrifty car and van rental business access is located within the junction as per the existing situation. However, the introduction of the cycleway and the proposed signal staging has the potential for the following safety issues to occur:

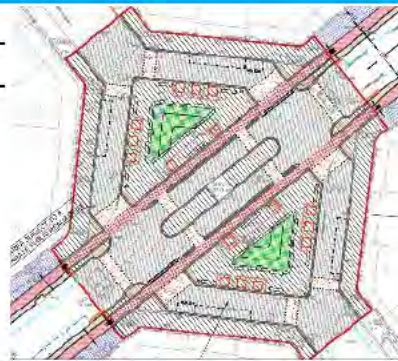
| <i>Drawing(s)</i> | TDD-636809-2.6-DR-CH-00-0006 |

| <i>Summary:</i> | Insufficient signs and markings could lead to head-on collisions |

The junction is being amended with new central islands proposed to separate the traffic streams. However, as each of the four sections of Melville Crescent around the diamond remain wide in order to incorporate parking, it may not be apparent to motorists on Melville Street as to the one-way nature of the sections. As such, motorists may turn into sections travelling the wrong way with the potential for head-on collisions to occur.

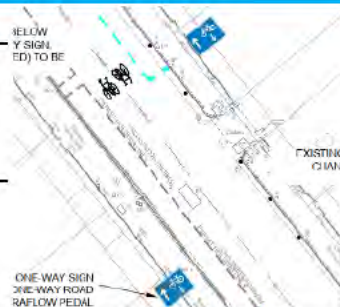
| Drawing(s) | TDD-636809-2.7-DR-CH-00-0007 TDD-636809-2.9-DR-CH-00-0009 TDD-636809-2.10-DR-CH-00-0010 TDD-636809-2.11-DR-CH-00-0011 |

| Summary: | Amended one-way route could lead to vehicular-cyclist collisions at junction |

At several locations, routes are proposed to be amended from one-way to one-way with contraflow cycles. Motorists exiting a side road onto these routes will be accustomed to looking in a singular direction to determine whether vehicles are approaching, before moving onto the adjoining road. Should they continue to do this, without looking in the other direction, then vehicular-cyclist collisions could occur. This occurs at the following locations:

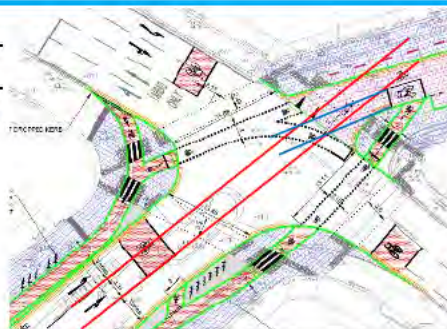
| Drawing(s) | TDD-636809-2-DR-CH-SK-0030 |

| Summary: | Lane alignment through junction could lead to head-on, side-impact, vehicular-cyclist, vehicular-pedestrian, and / or loss of control collisions |

The red lines in the image above show the path that vehicles travelling from Melville Street to Randolph Place will take across the junction. The blue lines in the image above show the path that vehicles intending to turn right from Randolph Street will take. There is the potential for head-on and / or side-impact collisions to occur when these two traffic streams have a green signal at the same time.

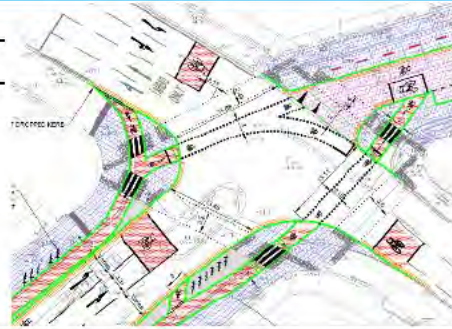
| <i>Drawing(s)</i> | TDD-636809-2-DR-CH-SK-0030 |

| <i>Summary:</i> | Concurrent signal phases could lead to cyclist-cyclist and / or cyclist-pedestrian collisions |

The signal staging for the junction proposes that the cycle crossing from Melville Street (phase L) that leads to Randolph Place and Queensferry Street runs at the same time as the pedestrian and cycle crossings on Queensferry Street (phases K and I). This could lead to cyclist-cyclist and / or cyclist-pedestrian collisions.

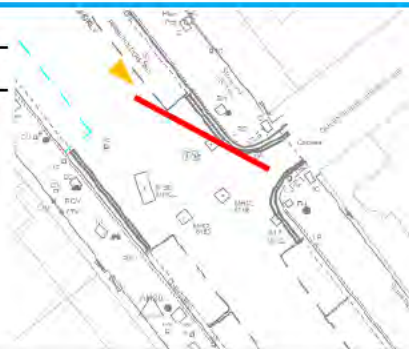
Drawing(s) TDD-636809-2.10-DR-CH-00-0010

Summary: Restricted visibility could lead to vehicular-cyclist collisions

It is proposed to convert Stafford Street from one-way northbound to one-way northbound with a southbound cycle contraflow. Motorists will now need to be able to see a cyclist approaching from the north. However, existing parking bays limit visibility at this location. There is a risk of motorists exiting the side road not seeing a cyclist in the area outside of the visibility splay i.e. adjacent to the parked vehicles, with the potential for collisions between the two. (In the image above the approximate visibility splay is shown in red, with the hidden cyclist shown as the orange triangle).

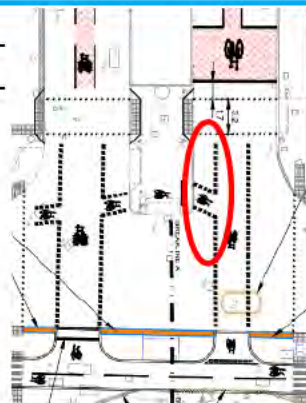
Drawing(s) TDD-636809-3-DR-CH-SK-0024

Summary: Width of cycle lane and adjacent traffic lane could lead to shunt collisions between vehicles and cyclists

Road markings are proposed to guide cyclists from the existing central cycle lane on George Street eastbound across St Andrew Square onto the new segregated cycleway. However, the cycle lane is much wider through this section, such that a vehicle in the offside right turn lane will straddle it. If a cyclist exits the junction when there is no offside vehicle adjacent they may seek to utilise the full width of the marked cycle lane. If they do this when they are immediately in front of an offside vehicle, they will move across the front of that vehicle, with the potential for shunt collisions.

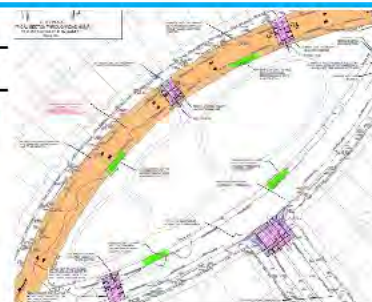
| Drawing(s) | TDD-636809-2.2-DR-CH-00-0002 |

| Summary: | Steep ramps could lead to collisions between vehicles and wheelchair users |

Raised tables are proposed directly adjacent to accesses into the central gardens at the locations described below:

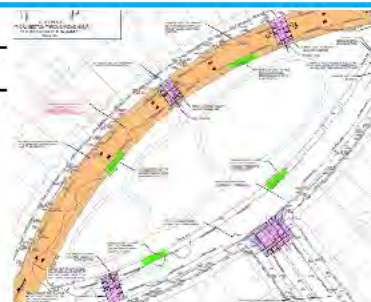
Drawing(s) TDD-636809-2.2-DR-CH-00-0002

Summary: Insufficient tactile paving could lead to vehicular-pedestrian collisions and / or trips and falls for visually impaired pedestrians

Insufficient tactile paving has been provided at the following raised tables:

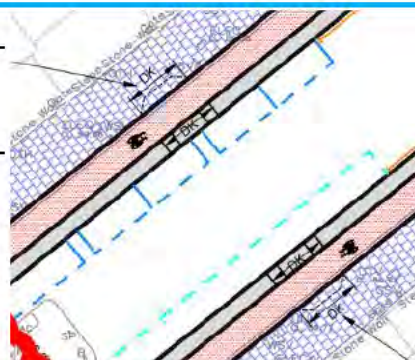
Drawing(s) TDD-636809-2.5-DR-CH-00-0005
TDD-636809-2.6-DR-CH-00-0006
TDD-636809-2.7-DR-CH-00-0007

Summary: Lack of tactile information for the visually impaired could lead to cyclist-pedestrian and / or vehicular-pedestrian collisions

Dropped kerbs are provided within the footway on both sides of Melville Street, either side of the cycleways. However, there is nothing to inform the visually impaired that, should they follow this route, they will be entering the cycleway, and then the road. This could result in cyclist-pedestrian and / or vehicular-pedestrian collisions.

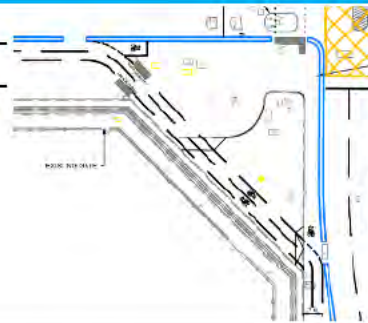
Drawing(s) TDD-636809-4-DR-CH-SK-0007

Summary: Small radii in cycleway could lead to head-on and / or loss of control cyclist collisions

Several of the radii in the proposed cycleway around Charlotte Square appear to be very small. This could lead to cyclists being unable to stay in their lane, with the potential for colliding with a cyclist travelling in the opposite direction. They could also lead to cyclist losing control as they attempt to follow the radius at speed.

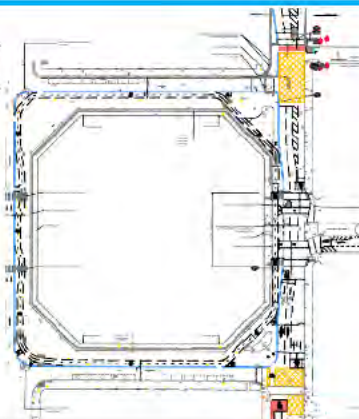
Drawing(s) TDD-636809-4-DR-CH-SK-0007

Summary: Unclear route for cyclists could lead to cyclist-pedestrian collisions and / or vehicular-cyclist collisions

Cyclists travelling northbound on South Charlotte Street are guided to use the proposed cycleway around Charlotte Square. Should these cyclists wish to continue to the north, it is unclear how they are to re-join the carriageway. It appears as though they would have to use the pedestrian crossing of Charlotte Square (northern side), with the potential for collisions with pedestrians, and then cut across the pedestrian crossing of North Charlotte Street, again with the potential for collisions with pedestrians. Similarly, it is unclear how cyclists joining the proposed cycleway from the northern side of the square intending to travel southbound are to re-join the carriageway. They may also have to use pedestrian crossings, with the risk of collisions with pedestrians, or may have to judge a suitable gap to join the South Charlotte Street junction, with the potential for being struck by a vehicle.

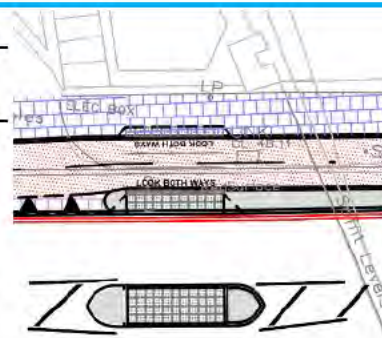
Drawing(s) TDD-636809-1.4-DR-CH-00-0004
TDD-636809-1.5-DR-CH-00-0005

Summary: Narrow pedestrian area could lead to cyclist-pedestrian and / or vehicular-pedestrian collisions

At several locations a narrow area is provided for pedestrians between the cycleway and the road. Pedestrians will need to wait within this area until it is safe to cross. However, the narrow width of these areas means that there is the potential for pedestrians with prams or wheelchair users to overhang the adjacent cycleway or road, with the potential for cyclist-pedestrian or vehicular-pedestrian collisions to occur respectively.

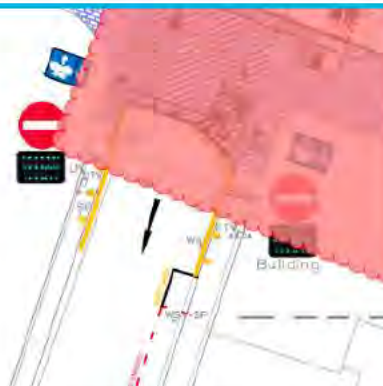
Drawing(s): TDD-636809-1.1-DR-CH-00-0001 & TDD-636809-1.2-DR-CH-00-0002

Summary: Conflicting road signs and road markings could lead to head-on collisions

The proposed road signs on Drawing 1.1 indicate that Roseburn Gardens is to be one-way southbound, with contraflow cycles permitted northbound. However, drawing 1.2 indicates that Roseburn Gardens is to be two-way for all vehicles. Motorists entering from Roseburn Terrace heading southbound will not be expecting motorists approaching from the opposite direction. They will be more likely to travel in the centre of the road and may assume that the road markings at Roseburn Place are for a two-lane exit. As such there is the potential for head-on collisions between southbound vehicles and vehicles / cyclists turning left into Roseburn Gardens, noting the restricted visibility on the corner.

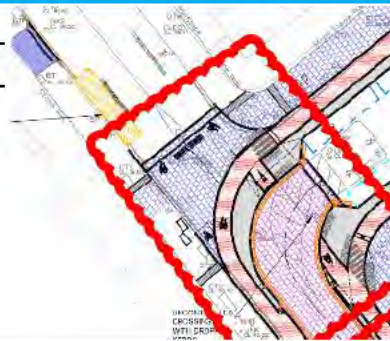
Drawing(s) TDD-636809-2.5-DR-CH-00-0005

Summary: Unrestricted access could lead to vehicular-pedestrian and / or vehicular-cyclist collisions

There is nothing to prevent southbound motorists on Manor Place from entering the proposed raised table at Melville Street. If they were to do this, they would have to drive over the pedestrian and cycle waiting areas in order to turn left onto Melville Street, with the potential for vehicular-pedestrian and / or vehicular-cyclist collisions to occur.

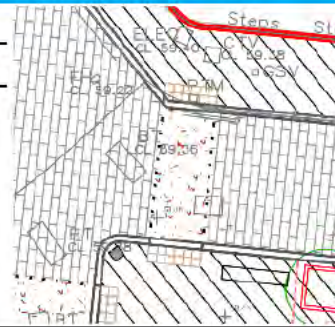
| <i>Drawing(s)</i> | TDD-636809-2.6-DR-CH-00-0006 |

| <i>Summary:</i> | Unusual road markings at crossings could lead to vehicular-pedestrian collisions |

All of the proposed crossings at the junction appear to be uncontrolled crossings as there are no traffic signals shown. However, all of the crossings are bounded by stud markings, which users would normally expect to see at controlled crossings. This may lead pedestrians into thinking they have right of way, whilst the lack of stop lines might lead motorists into thinking that they have right of way, with the potential for vehicular-pedestrian collisions.

It is recommended that road markings are provided as per the TSRGD.

Recommendation accepted.

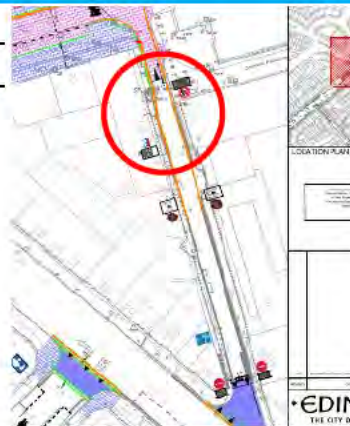
Drawing(s) TDD-636809-2-DR-CH-SK-0030

Summary: Position of signs could lead to vehicular-cyclist collisions

Signs are proposed to indicate that motorists travelling southbound must give way to cyclists travelling northbound. However, these signs are placed away from the narrow section at the northern end of the road, which is the most critical point where vehicular-cyclist collisions could occur.

It is recommended that the Give Way to Oncoming Vehicles sign is located at the start of the narrow section for southbound vehicles, and the Priority Over Oncoming Vehicles sign is located at the start of the narrow section for northbound cyclists.

Recommendation accepted.

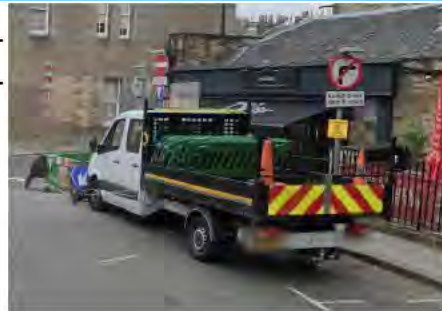
| <i>Drawing(s)</i> | TDD-636809-2.11-DR-CH-00-0011 |

| <i>Summary:</i> | Incorrect sign could lead to vehicular-cyclist or shunt type collisions |

Canning Street is to be amended such that no motor vehicles are permitted to access it through to Rutland Square. Currently buses, taxis and cyclists are permitted to turn right from Rutland Square into Canning Street as per the existing sign plate. Should buses or taxis start to turn right from Rutland Square they will be faced with a new splitter island and will have to reverse. This could lead to collisions with cyclists turning right or general vehicles exiting Rutland Square

It is recommended that the existing sign plate is replaced with an Except Cycles plate.

Recommendation accepted.

Sign plate will be replaced.

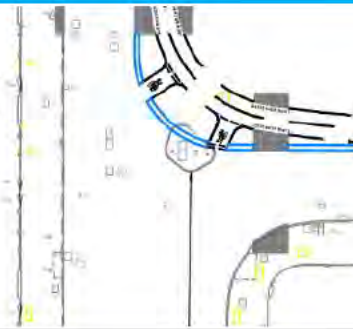
| <i>Drawing(s)</i> | TDD-636809-4-DR-CH-SK-0007 |

| <i>Summary:</i> | Lack of delineation of junction and one-way route could lead to side-impact and / or head-on collisions |

The existing inner kerb line on Charlotte Square is being relocated into the carriageway, and Charlotte Square is being made one-way. However, there is nothing to inform motorists approaching the Hope Street / Charlotte Square or Glenfinlas Street / Charlotte Square junctions from either direction as to who has right of way. This could lead to side-impact collisions. It could also lead to head-on collisions in the event that motorists turned right onto Charlotte Square.

It is recommended that road markings are provided at the junction, and appropriate signage and road markings are provided to convey the one-way route.

Recommendation accepted.
